### **Decision Notice – Approval**

Subject 6 Millchester Road Condition Assessment

Subject 4 Millchester Road Condition Assessment

## Heritage Assessment, Building Condition and Demolition Report

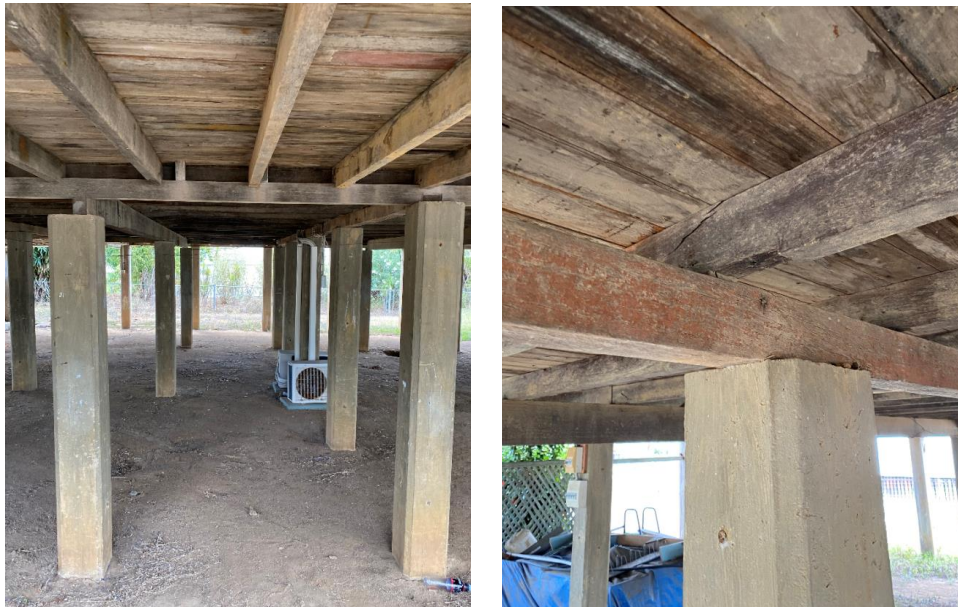
**Figure 3:** Timber Floor Framing

The building was inspected externally to determine the condition of the visible structural elements. From the inspection, the timber floor framing was found to be weathered, with some isolated areas of rot and splitting evident. Evidence of overstress and deflection was also evident in the timber framing with cracking identified in isolated joists. It is noted that

there was no positive fixing evident between the floor framing and concrete stumps, with exception to isolated concrete stumps which supported columns over. The timber floor framing is shown in **Figure 3**.

- Installation of shear walls throughout the building;
- Replacement of deteriorated timber members (floor framing and roof framing);
- Strengthening of floor framing members which support roof loading; and
- Introduction of adequate fixings between the substructure and the timber floor framing.

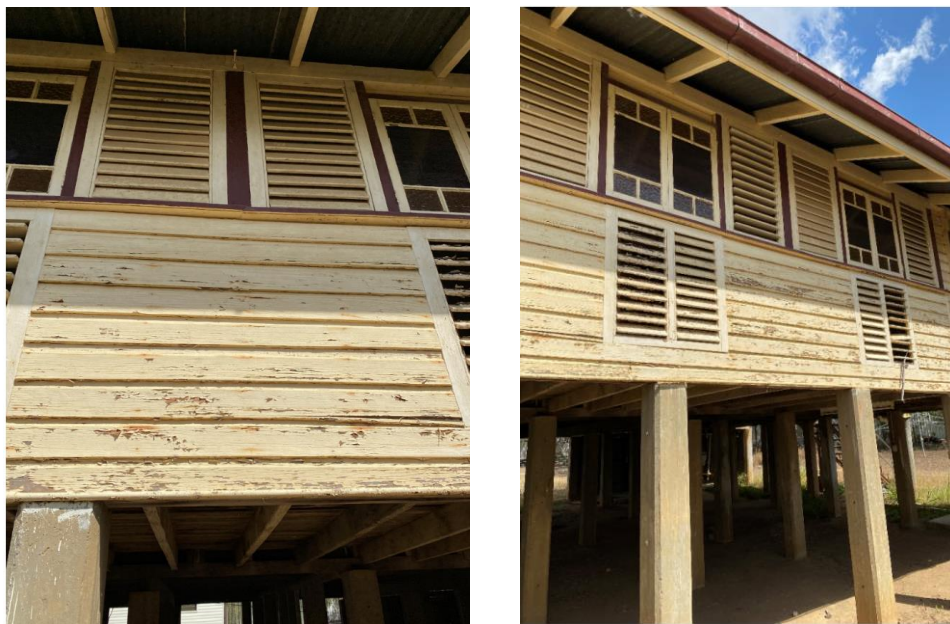
**Figure 4:** Deteriorated Cladding

The external wall cladding was identified to be timber weatherboard. The wall cladding was generally found to be in a deteriorated state with wear and tear and chipping evident to the majority of the cladding. The deteriorated cladding is shown in **Figure 4**.

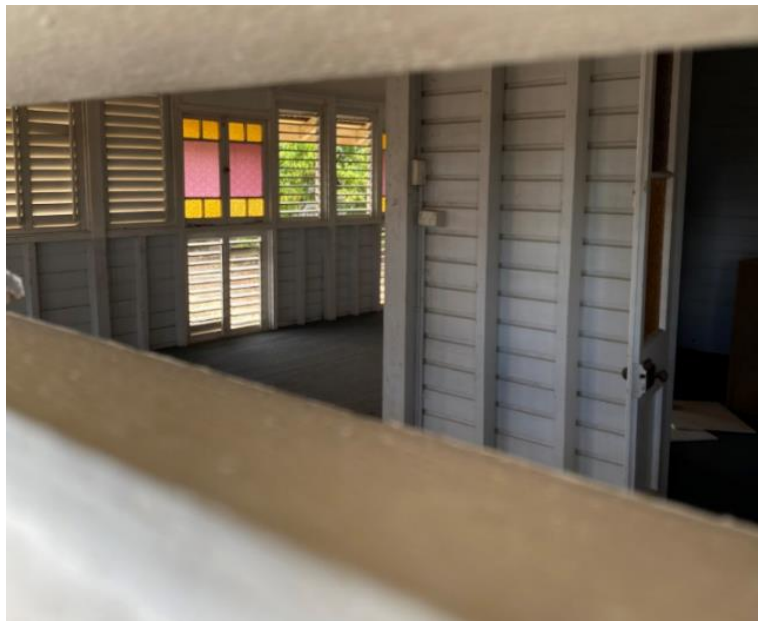
**Figure 6:** Internal Wall Framing

The internal wall framing of a building is generally used to provide resistance to lateral racking loads imparted on a building during a wind event. To achieve sufficient racking capacity the shear walls generally have plywood or similar fixed with specified nailing patterns and steel tie down rods at each end and at 1200mm centres. These rods are generally seen in the floor framing as they are required to anchor directly to the substructure. However, from the site inspection no tie down rods or any positive fixings were identified from the internal walls to the floor framing/substructure.

**Figure 6** shows the internal wall framing.

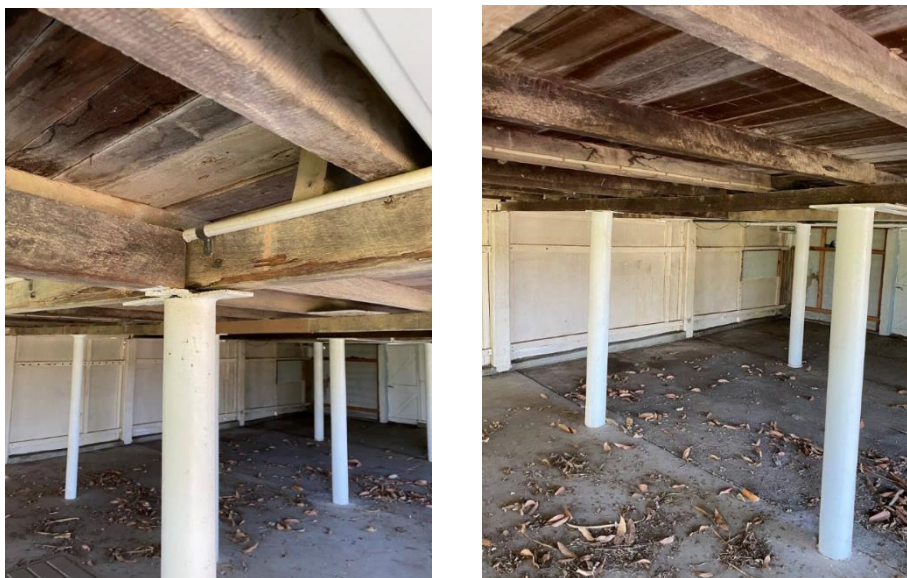
**Figure 3:** Timber Floor Framing

The building was inspected externally to determine the condition of the visible structural elements. From the inspection, the timber floor framing was found to be weathered, with some isolated areas of rot and splitting evident. In isolated timber members there was evidence of previous termite damage.

The timber joists were measured on site to be 100mm x 50mm hardwood members with a span of approximately 2000mm. It is noted that both single and continuous span joists were identified on site. The timber bearers were found to be continuous members and were measured to be 100mm x 75mm hardwood members with a span of approximately 2100mm. Evidence of overstress and deflection was evident in the timber framing with cracking identified in isolated joists. From a structural assessment of the timber joists and bearers it was found that the both the bearers and joists do not comply with today's relevant Australian Standards. The joists fail in serviceability whilst the bearers fail both strength and serviceability.

From the inspection no positive fixing was evident between the floor framing and the supporting members (concrete stumps and steel posts). The timber floor framing is shown in **Figure 3**.

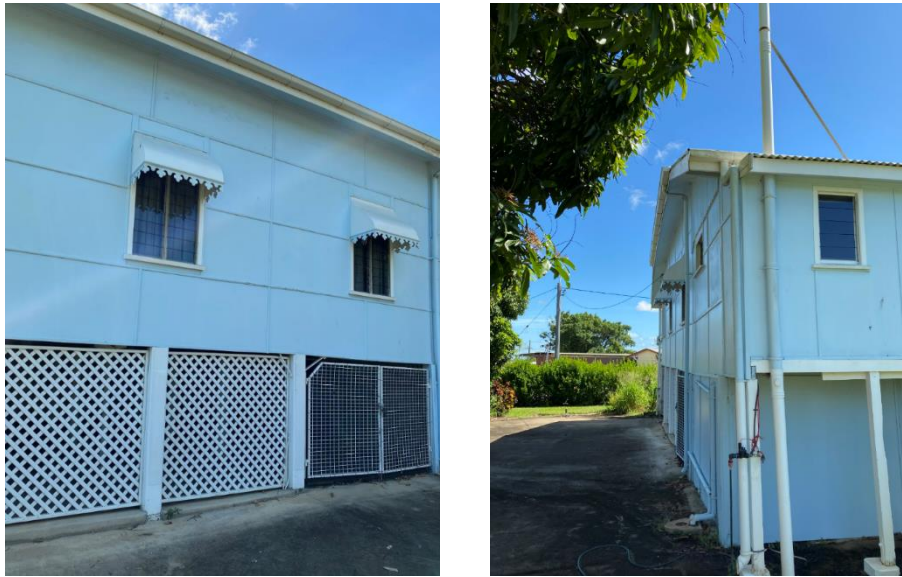
Figure 4: Cladding

The external walls were found to be in a moderately weathered state with minor wear and tear evident to the majority of the cladding. Although testing was not undertaken, Langtree Consulting understand that asbestos is present to the external cladding.

The deteriorated cladding is shown in **Figure 4**.

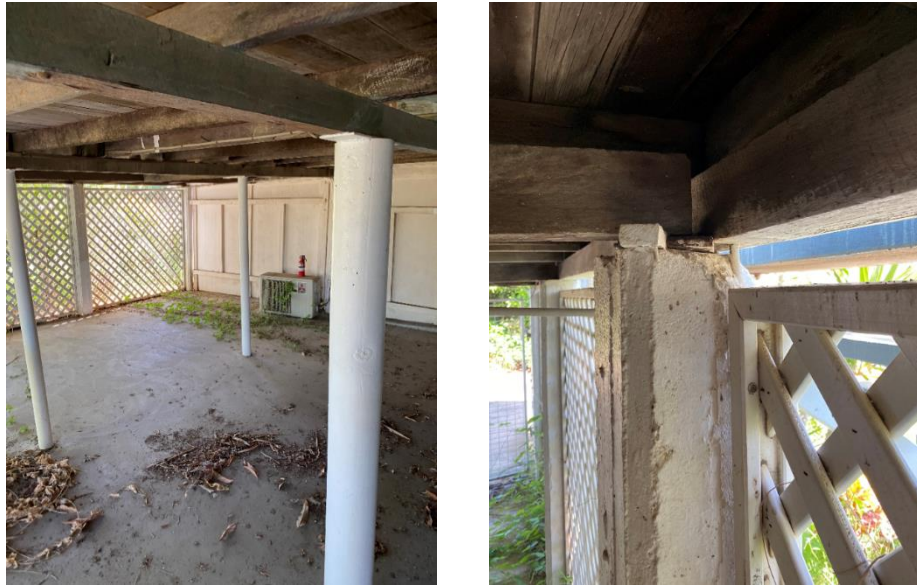
The external walls were generally found to support the roof structure however, it is noted that the fixing from the roof structure to the external wall could not be seen during the inspection. For a building of this configuration, tie down rods would be expected to be present to the external walls and fixed to the timber floor framing. However, from the site inspection no tie downs could be identified. No positive fixing was identified between the timber floor framing and concrete/steel posts. **Figure 5** shows the floor framing with no identifiable tie downs.

**Figure 5:** Concrete Post with No Identifiable Fixing
