Decision Notice – Approval
(Given under Section 63 of the *Planning Act 2016*)

Application number: BWAP20/133
Approval type: Preliminary Approval
Development type: Building Works Assessable
Category of assessment: Impact Assessment
Description of development: Demolition of a Local Heritage Place – Dwelling House
Definition of use: N/A
Categorising instrument: Charters Towers Regional Town Plan Version 2

Subject 8 Millchester Road Condition Assessment

8 Millchester Road, Charters Towers HERITAGE IMPACT REPORT

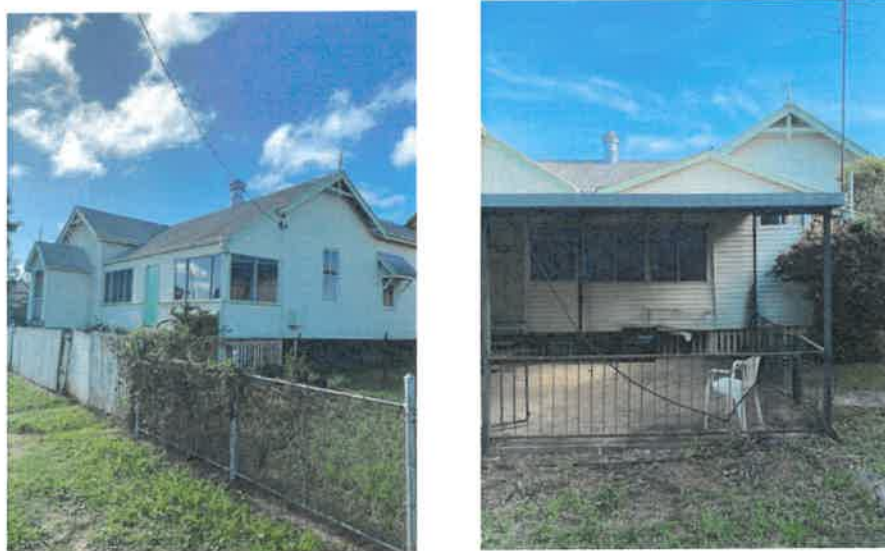
Figure 2: 8 Millchester Road, Charters Towers

The building located at 8 Millchester Road, Charters Towers, is shown in **Figure 2** below.

The building is a single storey low set timber stud framed residential structure which consists of a combination of concrete stumps and SHS posts which support timber floor framing. The wall framing consisted of weatherboard clad walls. The roof cavity was not inspected at the time of the inspection; however, it is assumed that the roof structure consists of timber rafters.

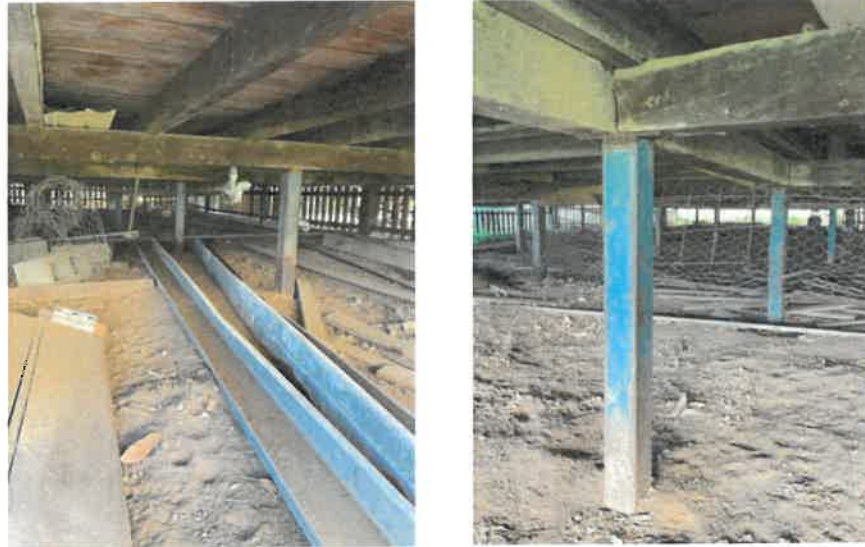
The building was inspected externally to determine the condition of the visible structural elements. The posts supporting the building are a combination of circular concrete stumps (believed to be the original posts) and square hollow sections, which have been installed at a later date. It is noted that the majority of the concrete stumps have been replaced, with exception to two (2) stumps in the south-eastern corner of the building.

From the inspection, the posts appear to be settling at some locations. This is evident by the sagging of various perimeter walls. The posts supporting the building are shown in **Figure 3** below.

Figure 3: Posts supporting timber floor framing.

- As settlement was identified in various walls due to movement in the foundations, it is likely that the timber framing has sustained damage over time as a result of this settlement.

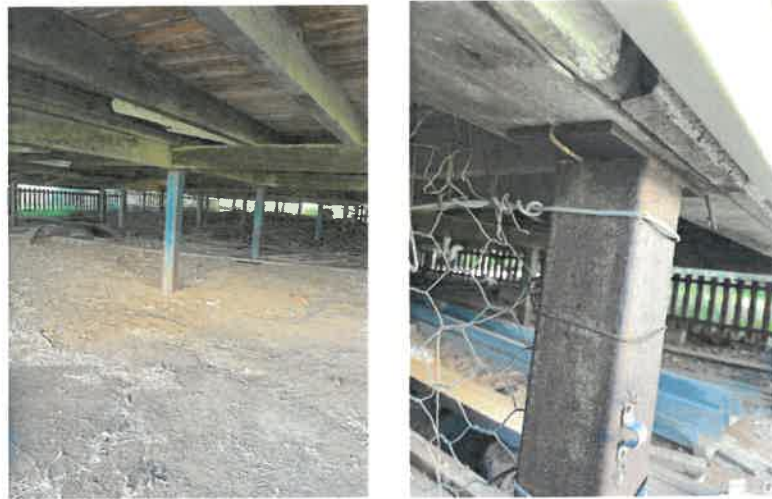
From the inspection, the timber floor framing was found to be weathered, with some isolated areas of rot and splitting evident. Evidence of overstress and deflection was also evident in the timber framing with cracking identified in isolated joists. It is noted that there was no positive fixing evident between the floor framing and concrete stumps / SHS posts. The fixing between the floor framing to steel posts consisted of a nail embedded in the timber bearers then bent over the column end plate. The timber bearers were measured on site to be 125mm x 100mm hardwood members with a span of approximately 2400mm (continuous span). The timber joists were measured on site to be 100mm x 50mm hardwood members with a span of approximately 2000mm, with exception to the eastern side of the building which had joist spans of approximately 3000mm. The joists were a mixture of single span and continuous.

Evidence of overstress and deflection was evident in the timber framing with cracking identified in isolated joists. From a structural assessment completed on the timber framing, the bearers and 2400mm spanning joists were found to have sufficient capacity for floor loading. However, the joists on the eastern side of the building with a 3000mm span do not comply with today's relevant Australian Standards. It is noted that the floor framing was not

checked for wind loading and an applied wind loading would likely fail the floor framing. The timber floor framing is shown in **Figure 4**.

Figure 4: Timber Floor Framing

- Timber Floor Framing
 - The timber floor framing was identified to be weathered and splitting is occurring to various members. No positive fixing was identified between timber members or from the bearers to the concrete stumps / RHS posts.

- The timber bearers were found to have sufficient capacity for today's relevant Australian Standards (floor loading only).
 - Any applied wind load would overstress the bearers.

- The joists with 2000mm spans were found to have sufficient capacity for today's relevant Australian Standards (floor loading only).
 - The joists with 3000mm spans (eastern side of the building) were found to have insufficient capacity for today's relevant Australian Standards (floor loading only).

- Installation of tie down rods to walls which support roof load;
- Installation of shear walls throughout the building;
- Replacement of deteriorated timber members (floor framing and roof framing);
- Replacement of deteriorated roof sheeting;
- Repair/reinstatement of wall framing where sagging/settlement has occurred;
- Strengthening of floor framing members which support roof loading;
- Strengthening of joists with spans in excess of 2000mm; and
- Introduction of adequate fixings between the substructure and the timber floor framing.

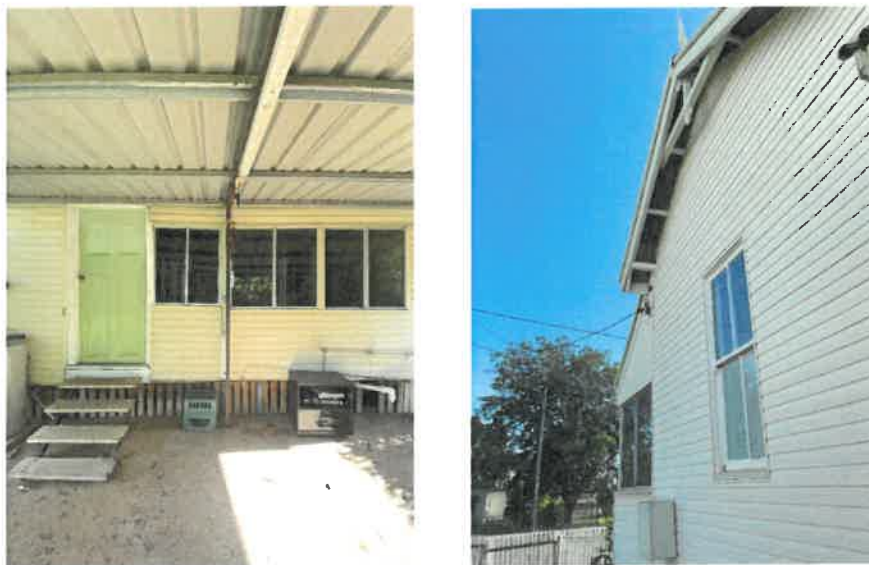
The external walls consist of weatherboard cladding and were found to be in a fair state with minor wear and tear evident to the majority of the external walls. The walls were observed to be sagging at some locations, indicating differential settlement of the foundations. The sagging/settlement was most prominent at the rear of the property adjacent to the door and window framing. The cladding is shown in **Figure 5**.

Figure 5: Weatherboard Cladding

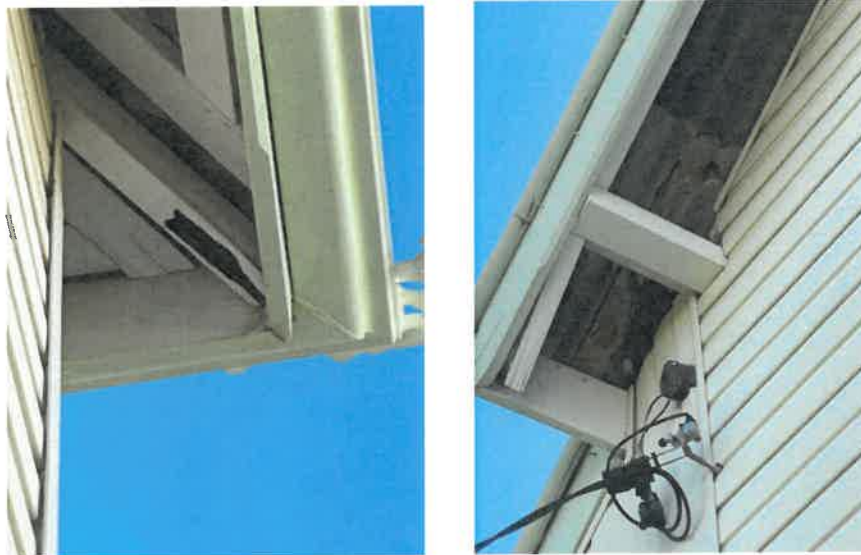
The fixing from the roof structure to the external wall could not be seen during the inspection. It is assumed that wall studs with a top plate are supporting the roof structure. It is also noted there was no soffit lining present. As a result of the absence of soffit lining the exposed rafters could be inspected and were found to be rotting in various locations and the corrugated iron roof is corroding with section loss evident in various areas of the sheeting. It was also observed that the fascia board is damaged and roof gutters are severely corroded in some locations.

For a building of this configuration, tie down rods would be expected to be present to the external walls and fixed to the timber floor framing. However, from the site inspection no tie downs could be identified.

Figure 6 shows an example of the damaged rafters, fascia board and roof sheeting.

Figure 6: Deteriorated roof structure

Based on the identified defects to the existing structure and the significance of the building, relocation of the building is possible with strengthening required to the majority of the building, to ensure it can withstand the loads required by today's relevant Australian Standards. The strengthening works would need to consist of the following:
