### **Decision Notice – Approval**

Subject 6 Millchester Road Condition Assessment

Subject 4 Millchester Road Condition Assessment

## Heritage Assessment, Building Condition and Demolition Report

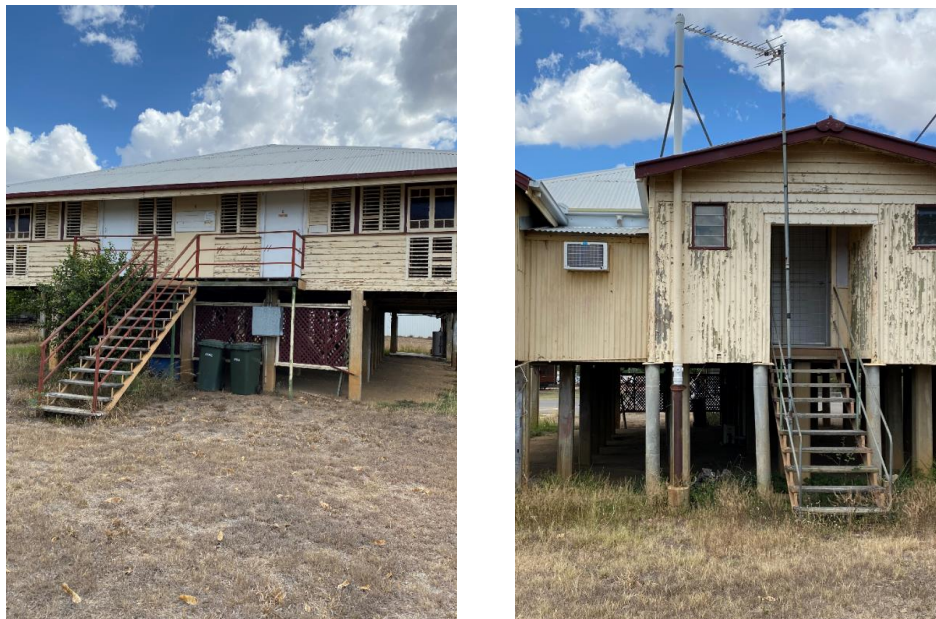
**Figure 2:** 6 Millchester Road, Charters Towers

The building is a two (2) storey residential structure which consists of concrete stumps which support timber floor framing. The wall framing consisted of timber framing with asbestos sheeting. The roof cavity was not inspected at the time of the inspection; however, it is assumed that the roof structure consists of timber rafters or trusses.

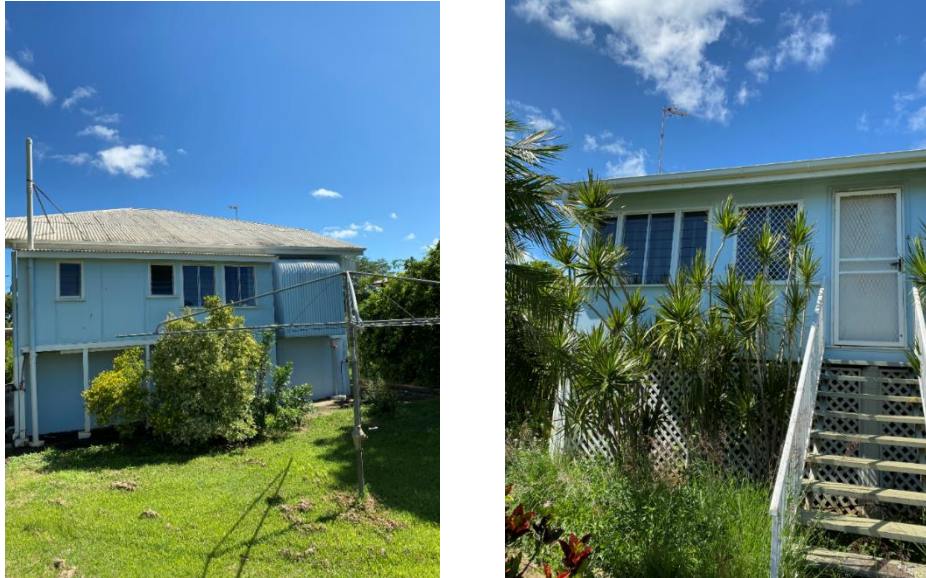
**Figure 2:** 4 Millchester Road, Charters Towers

The building is a two (2) storey residential structure which consists of concrete stumps to the external perimeter of the building and steel circular hollow posts internally, which support the timber floor framing. The wall framing consisted of timber framing with what appeared to be asbestos sheeting. The roof cavity was not inspected at the time of the inspection however, it is assumed that the roof structure consists of timber rafters or trusses.
